# TSD File Inventory Index

Compliance Evaluation Inspection

EPA I.D. No.: ILR 000 034 389

# ATTACHMENT NO. 1 PHOTO LOG

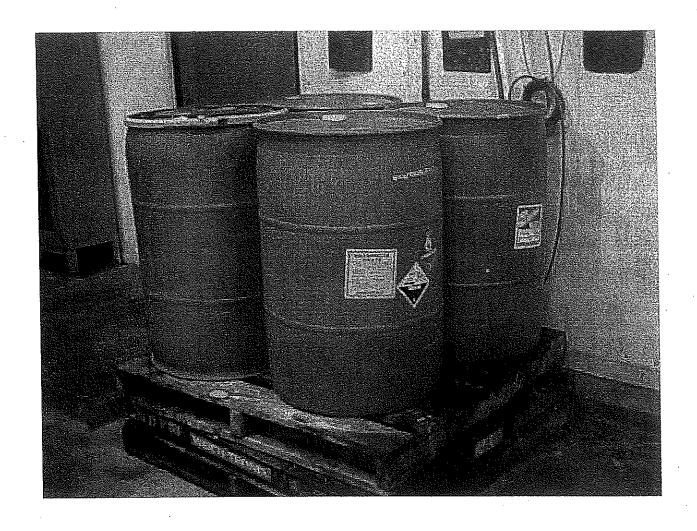
We started out in the Corrosive Fill Room where I observed the SAA dedicated to that area. At the time of the inspection, the Corrosive Fill Room SAA included one 55-gallon PVC drum of hazardous waste and three 55-gallon PVC drums of non-hazardous waste. (Photo #1). The drums were neatly arranged and resting upon several pallets, one atop the other. The drums were found to be in good condition, closed and properly labeled. There was no evidence of leakage from any of the drums.

**Photo No:** 1 **Date:** 7/25/03 **Site:** Univar **Description:** Corrosive Fill Room SAA: 1 55-gal HW; 3 55-gal non-HW.

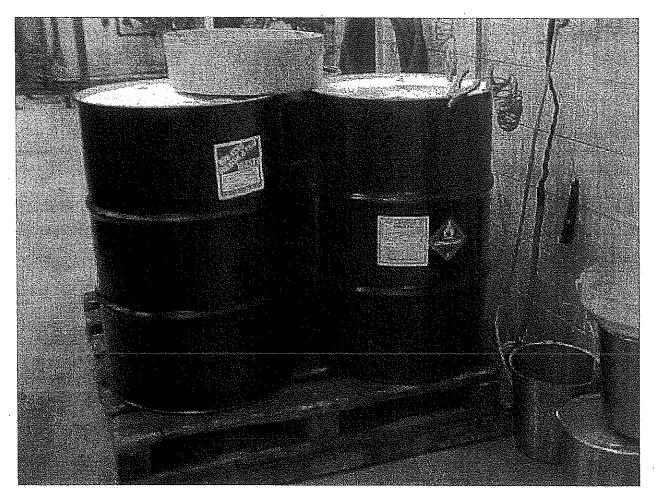
Photo No: 2 Date: 7/25/03 Site: Univar

From the Corrosive Fill Room SAA we proceeded to the Solvent Fill Room SAA. Here I observed three 55-gallon metal drums. (Photos #2 and 3). One drum contained spent solvents. It was grounded and found to be closed and in good condition. A HAZARDOUS WASTE label was affixed and filled out. A second drum, also affixed with a HAZARDOUS WASTE label contained used rags. A third drum contained non-hazardous materials. It was affixed with a NON RCRA REGULATED WASTE label. There was no evidence of spillage on or around these drums.

Description: Solvent Fill Room SAA: 1 55-gal solvent HW (grounded; foreground, to right); 1 55-gal solid (spent rags) HW (rear); 1 55-gal non-HW (foreground, to left).

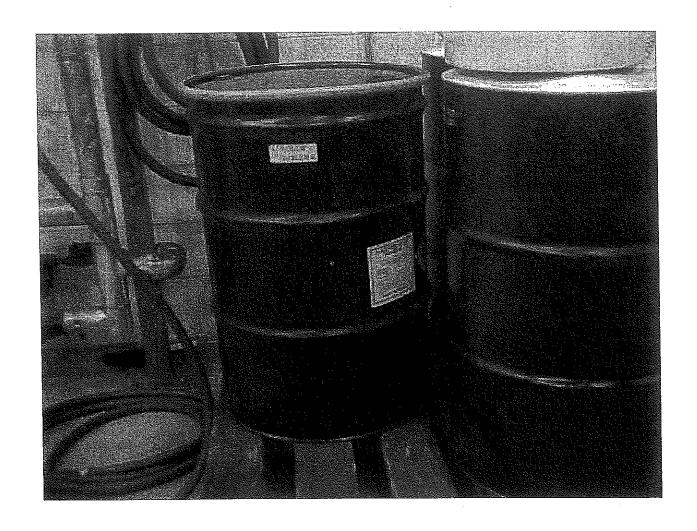
Photo No: 3 Date: 7/25/03 Site: Univar
Description: Solvent Fill Room SAA: 1 55-gal solvent HW (rear, to right)
foreground to right); 1 55-gal solid (spent rags) HW (left); 1 55-gal
non-HW (foreground, to right).

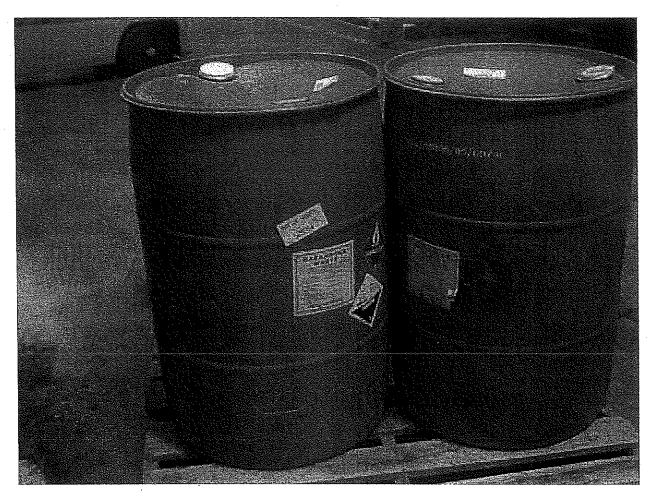
Drums are placed on pallets which are in turn placed on racks. There are three rack levels, and each level has its own sprinkler system (more discussion below). I asked Mr. Linos if I could view up-close some of the drums on the higher racks. He arranged for the forklift operator to take down one pallet upon which rested two 55-gal PVC drums containing waste organic acid, dated 7/17/03 and 7/21/03. (Photo #4). The drums were properly labeled, closed and in good condition.

**Photo No:** 4 **Date:** 7/25/03 **Site:** Univar **Description:** 90-day Accumulation Area — pallet removed from storage rack; shows 2 55-gal PVC drums containing waste organic acid; dated 7/17/03 and 7/21/03.

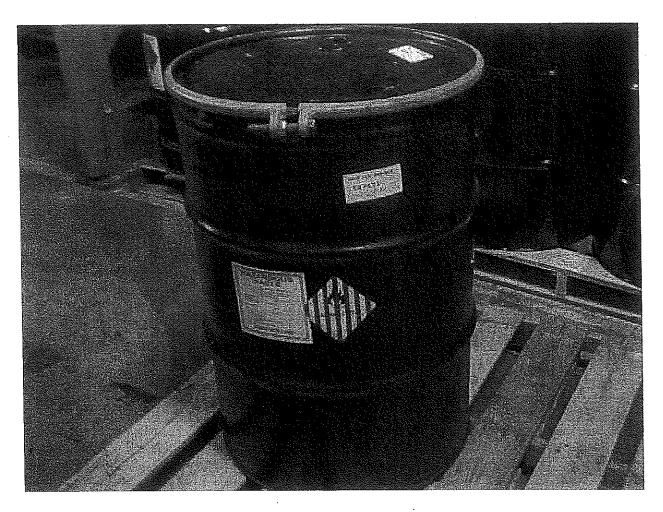
Photo No: 5 Date: 7/25/03 Site: Univar

Description: 90-day Accumulation Area — pallet removed from storage rack; shows 1 55-gal drum containing solid flammable liquid, D001; dated 7/22/03.

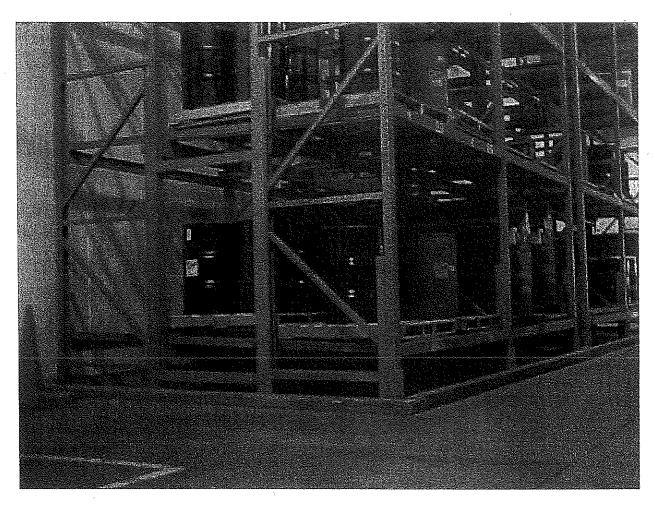
Photo No: 6 Date: 7/25/03 Site: Univar

Description: 90-day Accumulation Area — shows diking around HW temporary storage area; note also how concrete floor outside diked area slopes toward center aisle (toward right of photo).

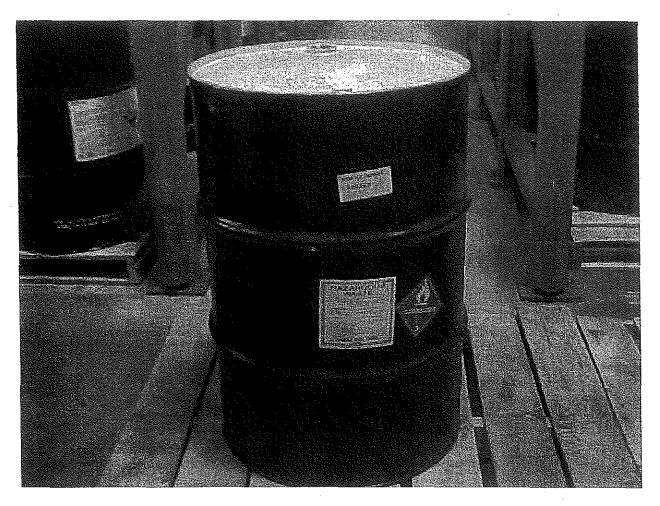
Photo No: 7 Date: 7/25/03 Site: Univar

Photo #7 shows a pallet removed from the storage rack, with one 55-gallon drum containing spent solvent, D001, D035, F003, F005, dated 7/16/03. The drum was properly labeled, closed and found to be in good condition.

Description: 90-day Accumulation Area — pallet removed from storage rack; shows 1 55-gal drum containing spent solvent, D001, D035, F003, F005; dated 7/16/03.

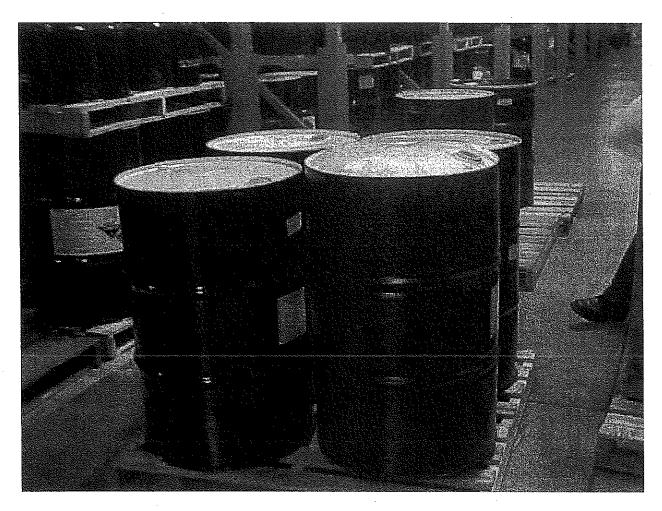
Photo No: 8 Date: 7/25/03 Site: Univar

Photo #8 shows a pallet removed from the storage rack. On it were four 55-gallon drums containing solid solvents, D001, D035, F003, F005. One of the drums (in foreground, to right of photo) was observed to be swollen. Mr. Linos made radio contact with a Univar USA employee, and the drum was promptly removed, vented and its contents were transferred to new drum.

Description: 90-day Accumulation Area — pallet removed from storage rack; shows 4 55-gal drum containing solid solvents, D001, D035, F003, F005; note drum in foreground, to right with bulging head. Drum was promptly removed, vented and contents were transferred to new drum.

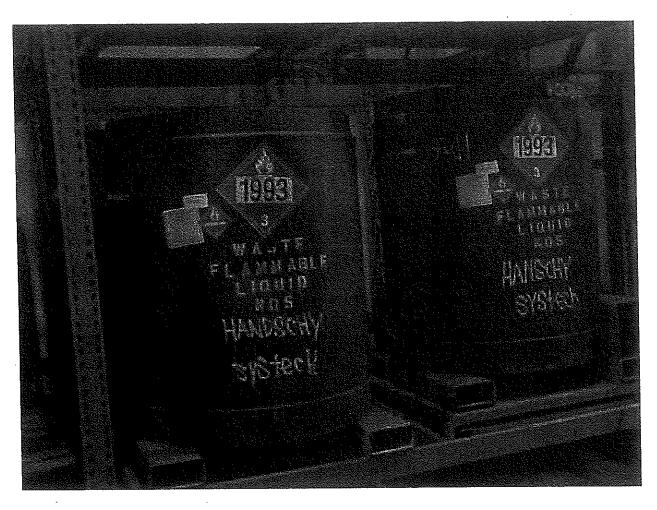
Photo No: 9 Date: 7/25/03 Site: Univar

I next observed five 330-gallon steel totes on the first level of the storage rack. These totes were affixed with HAZARDOUS WASTE labels. They contained flammable liquids, D001. The totes were closed and in good condition. There was no evidence of leakage anywhere in the rack containment system. (Photo #9.)

Description: 90-day Accumulation Area — 5 330-gal steel totes containing waste flammable liquid, D001.

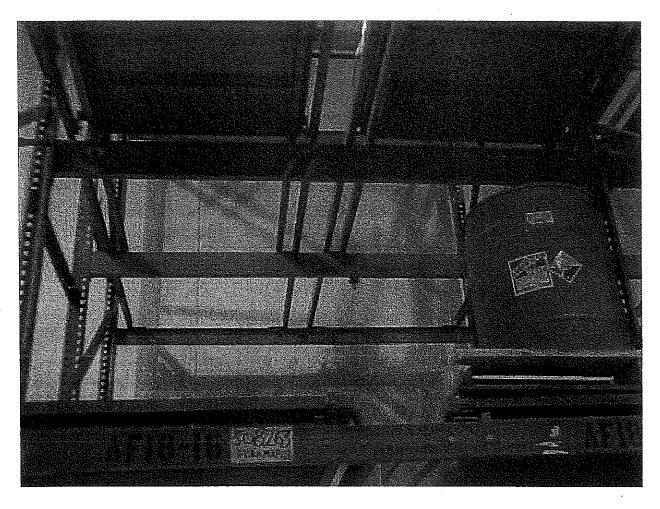
Photo No: 10 Date: 7/25/03 Site: Univar

Description: 90-day Accumulation Area — each level on rack has its own dedicated sprinkler; note piping and sprinkler on 2<sup>nd</sup> level, center of photo to left of drum.

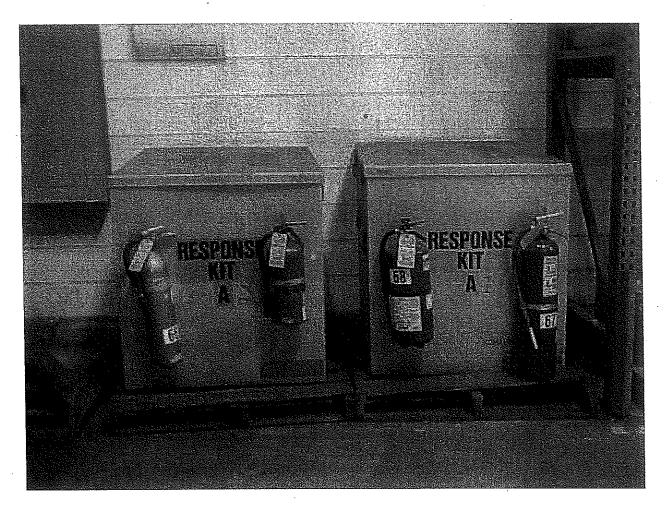
Photo #11 shows two large spill response boxes in the warehouse area. These are located approximately 75 ft from the 90-day hazardous waste storage area racks. The boxes include spill response kits. The photo also shows four fire extinguishers affixed to the spill kit boxes. The tags indicated the fire extinguishers are annually tested.

Photo No: 11 Date: 7/25/03 Site: Univar Description: Spill Response kits, with four fire extinguishers.
